MISCELLANEOUS PAPER SL-79-25

INVESTIGATION OF LIGHTWEIGHT CONCRETE AND MATERIALS, EAST LOS ANGELES COMPREHENSIVE HEALTH CENTER BUILDING

A. D. Buck and T. C. Liu

November 1979

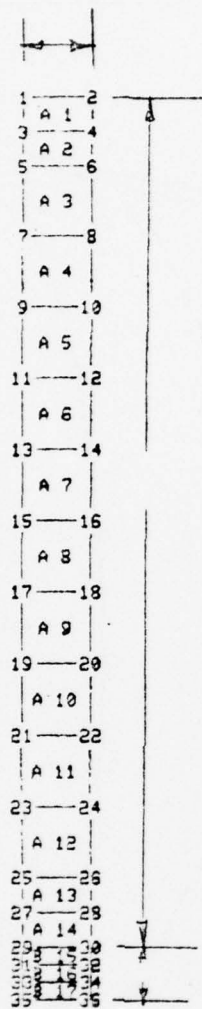
Figure 6. Finite-Element Model.

28. The finite-element model selected for temperature calculation is representative of a unit width of interior section of the lightweight concrete slab. The height of the finite-element model was 12-3/4 in., representing 12 in. of concrete slab and 3/4 in. plywood form. The finite-element model, consisting of 36 nodes and 17 elements, is shown in Figure 6.

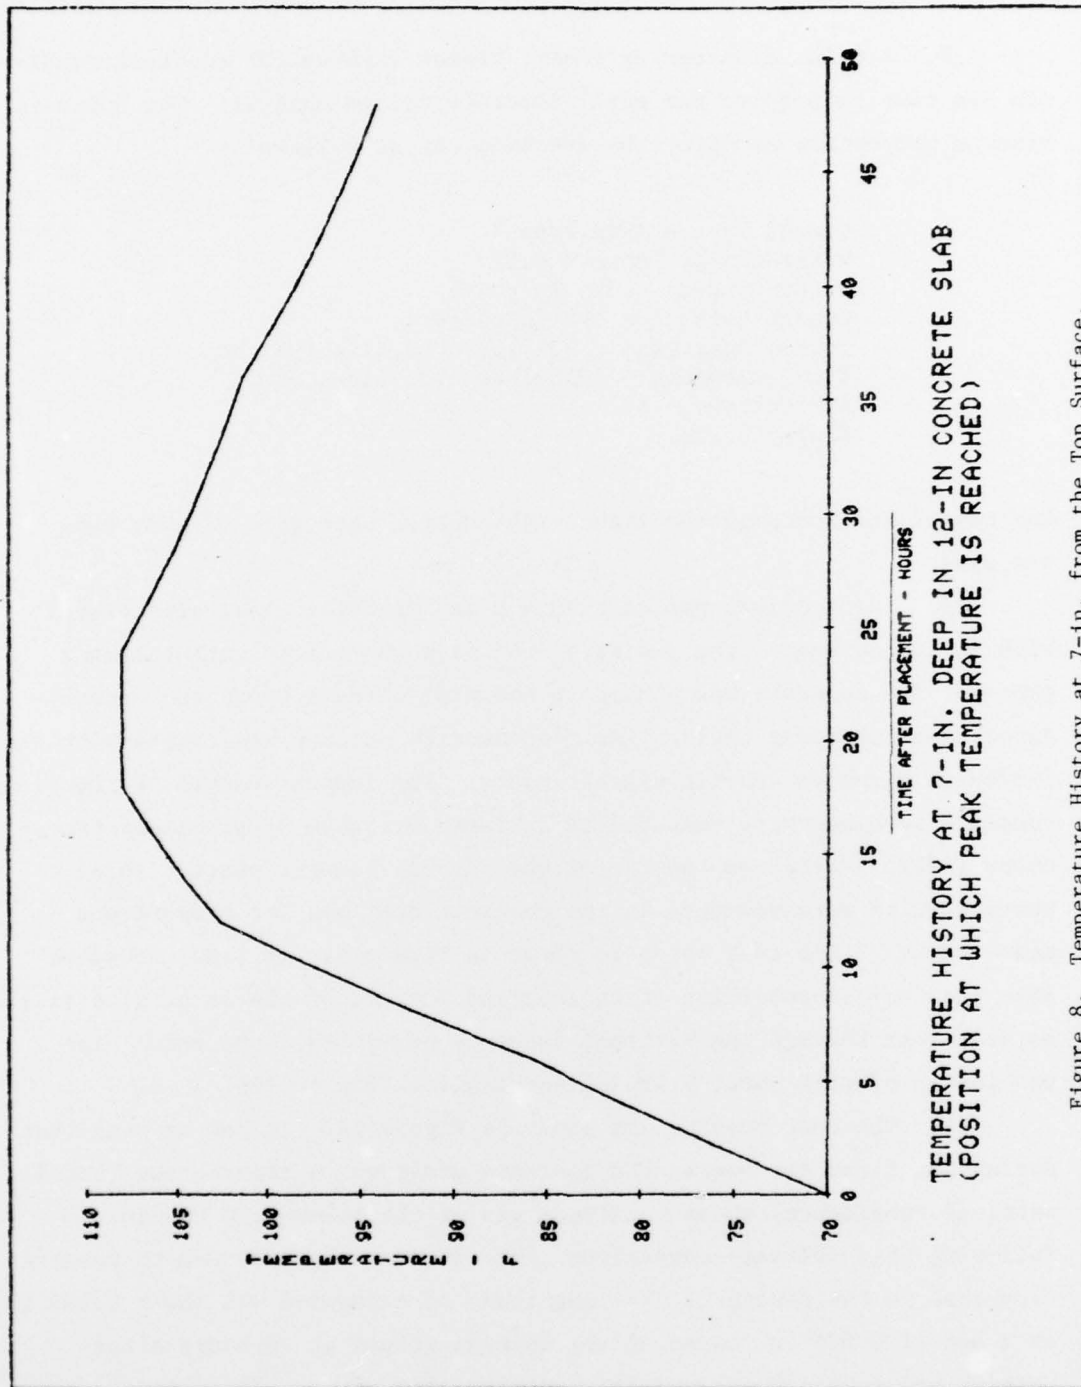
Figure 8. Temperature History at 7-in. from the Top Surface.

31. The calculated temperature distribution in the lightweight concrete slab is shown in Figure 7. It can be seen that peak temperatures of approximately 108°F were attained at about 19 hours after placement. The temperature history at 7 in. from the top surface (position at which peak temperature is reached) is shown in Figure 8. This temperature information was transmitted to Osborne Laboratories, Inc. through County of Los Angeles Facilities Department on 13 September 1978.

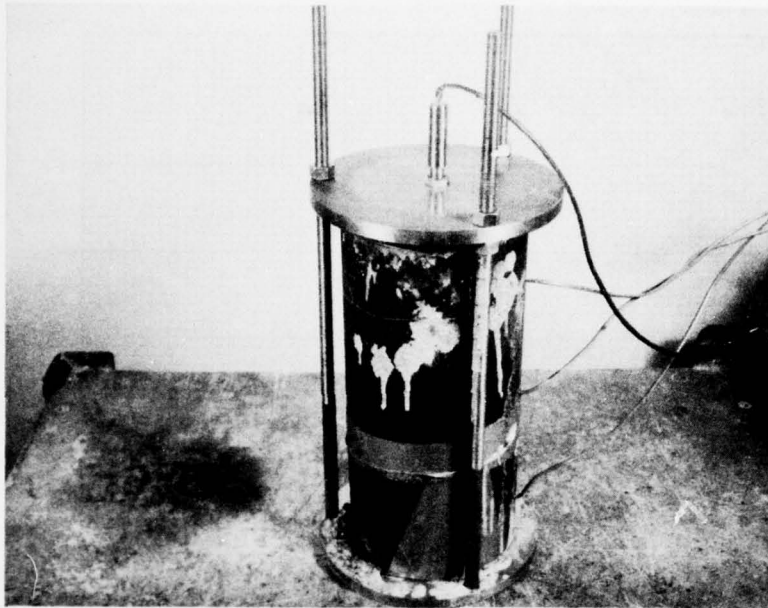
Figure 9. Test Setup for Early Volume Change Study.

33. The specimen was cast in a 6-in. diameter steel pipe fitted with a plywood base. The inside of the pipe was coated with silicone grease. The concrete was placed in the pipe using a scoop and consolidated on a vibrating table. The top concrete surface was capped with a 5-3/4-in. diameter acrylic plastic plate. The length changes of the concrete specimen were measured by a linear variable displacement transducer (LVDT) located on the top of the acrylic plastic plate. Three thermocouples were embedded in the concrete specimen for temperature measurements. The test setup is shown in Figure 9. In order to simulate the thermal condition of an interior portion of the large slab (i.e., no heat loss through the vertical faces is permitted), the steel pipe was insulated with about 8 in. of vermiculite (Figure 10).
